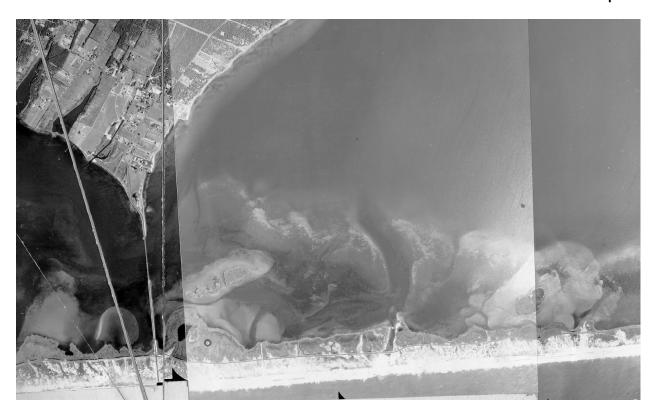
Figure IV-3-25. Shinnecock Bay, Long Island, New York, 30 June 1938. Photograph taken before the Great New England Hurricane of 21 September cut the barrier island in several locations. The present Shinnecock Inlet was cut where a channel crosses from the bay to the road. The channel may be a remnant of an artificial cut that was dug by the Shinnecock and Peconic Canal Company in 1896. Shoal areas in the bay near the barrier attest to former inlets that had been open long enough to form flood shoals. North is to the top, the water body in the center of the image is Shinnecock Bay, and the Atlantic Ocean is on the bottom. The image is part of a mosaic prepared by the Beach Erosion Board
